Erosion and Cavitation Repair of Kort Nozzle with Belzona Solutions

ID: 9522

Industry: *Marine*
Application: *SOS-Ships and Offshore Structures*

Substrate: *Carbon steel*
Products: *Belzona 1111 (Super Metal), Belzona 1341 (Supermetalglide)*

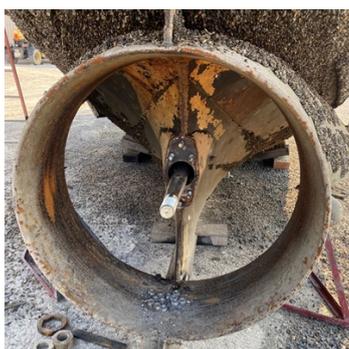
The Kort nozzle was damaged by erosion and cavitation, causing it to lose material and efficiency. This wear reduced its performance, making a strong and lasting repair necessary

General look of the affected area

Surface prep to SSPC 10 with a 3 mil profile, achieved through precision grit blasting. Then, thorough cleaning and degreasing with residue-free solvents. Once the substrate was properly cleaned, Belzona 1111 was mixed by volume and applied to smooth out pitted surfaces. Then applied the first coat of Belzona 1341, followed by a second coat within the overcoat window for optimal protection.

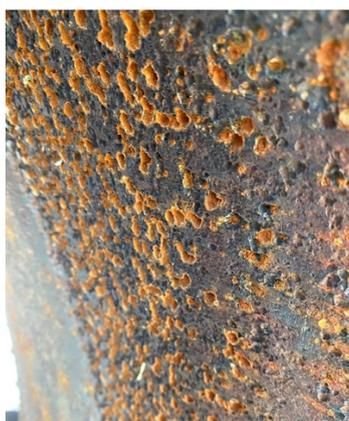
Closed-up look at the pits and damage of the nozzle

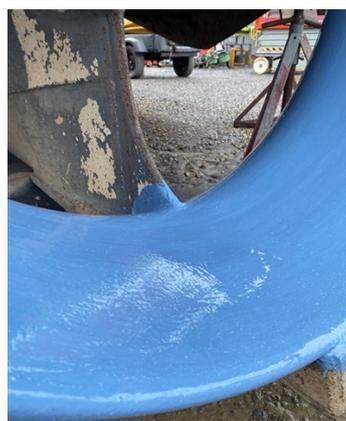
Close-up look at the coated areas once the job was completed

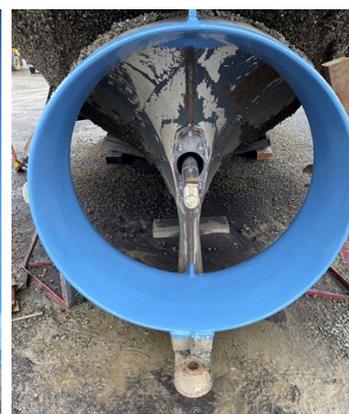
General look of the repaired equipment
