Tank base seal on oil storage tank

ID: 9525

Industry: Oil & Gas
Application: GSS-Gaskets, Seals and Shims
Substrate: Carbon steel
Products: Belzona 3131 (WG Membrane), Belzona 3921 (GSC Surface Conditioner), Belzona 6111 (Liquid Anode)

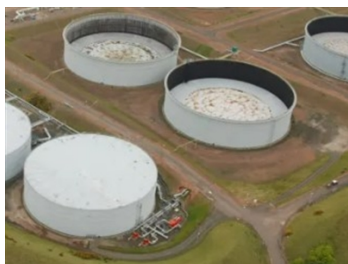
Tank farm

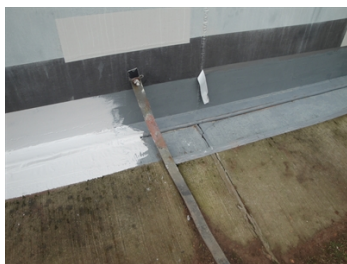
Belzona 3921 applied & 1st coat of Belzona 3131

The full tank circumference was grit blasted to SA2.5 & 75 microns in a 600mm band from tank wall to concrete base. Two coats of Belzona 6111 were first applied, then Belzona 3921. Following the recommended tank base sealing system bridging tape & foam backer rod were used to extend the bond line over the void between rim & concrete base. Belzona 9311 was then applied with Belzona 3131 to complete the system.

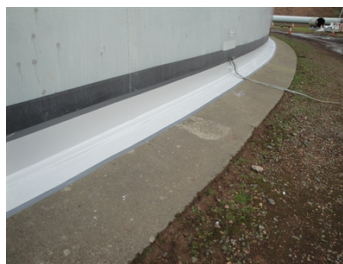
1st coat of Belzona 3131

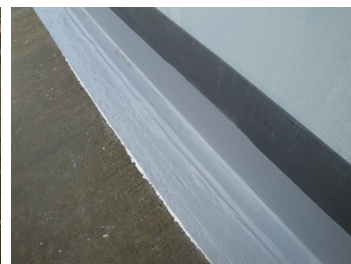
Completed application
