Belzona materials repair, protect and improve severely damaged diffuser for pump station

ID: 9528

Industry: Water / Wastewater
Application: CEP-Centrifugal Pumps
Substrate: Cast Iron
Products: Belzona 1111 (Super Metal), Belzona 1982 (SuperWrap II), Belzona 2141 (ACR-Fluid Elastomer), Belzona 2941 (Elastomer SP-Conditioner), Accessories

Customer Location: Longview, WA
Application Date: December 2022

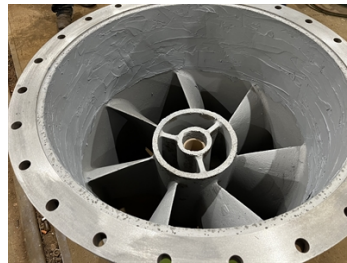
Initial Damage

Metal loss rebuilt with Belzona 1111 Super Metal

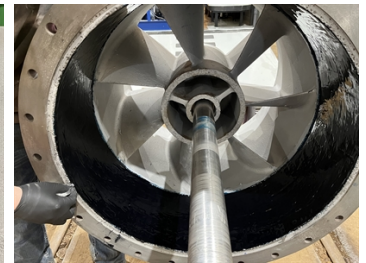
Exterior of diffuser reinforced with Belzona Superwrap II System

Interior of diffuser protected with two coats of Belzona 2141 ACR Elastomer (top coat of black shown)
