# BELZONA EMERGENCY RECLAMATION OF A REFINER

Industry: Pulp & Paper

Application: PDP-Positive Displacement Pumps

Customer Location: Paper mill, United Kingdom

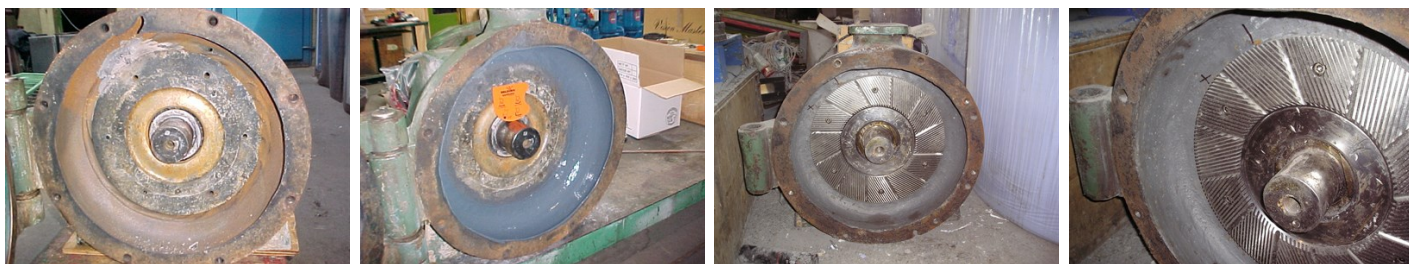
## Photograph Descriptions

Severe erosion in the refiner body and the end cover/door led to several holes necessitating repair

\* Refiner case prior to the application in 2000 , \* The August 2000 rebuild and coating , \* After seven years and one intermediate coating, still in excellent condition. The repair area was between the top two bolt holes , \* Close-up after application of another coat of Belzona® 1321 ,

The original application was carried out in accordance with Belzona Know-How System Leaflet PDP-6.

In 2004 the refiner was inspected and a further coat of Belzona® 1321 was applied. Now in December 2007 it has been checked again and found still to be in excellent condition.
