BELZONA EMERGENCY RECLAMATION OF A REFINER

ID: 953

Application: *PDP-Positive Displacement Pumps*

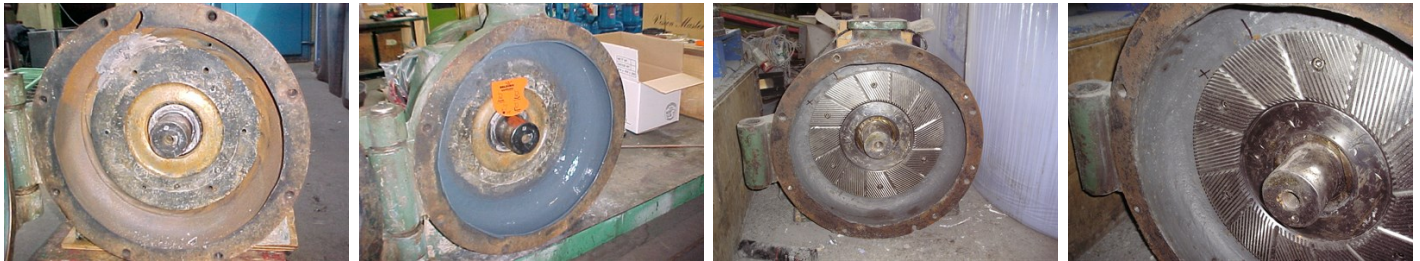
Photograph Descriptions

Severe erosion in the refiner body and the end cover/door led to several holes necessitating repair

* Refiner case prior to the application in 2000 , * The August 2000 rebuild and coating , * After seven years and one intermediate coating, still in excellent condition. The repair area was between the top two bolt holes , * Close-up after application of another coat of Belzona® 1321 ,

The original application was carried out in accordance with Belzona Know-How System Leaflet PDP-6.

In 2004 the refiner was inspected and a further coat of Belzona® 1321 was applied. Now in December 2007 it has been checked again and found still to be in excellent condition.
