Belzona slows down mold and mildew issue for local Council

Industry: Buildings & Structures
Application: WPA-Wall Problem Areas
Substrate: Other
Products: Belzona 5122 (Clear Cladding Concentrate)

Customer Location: Retford
Application Date: March 2024

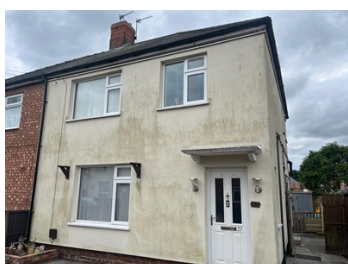
Rendered property suffering a build up of mold and mildew

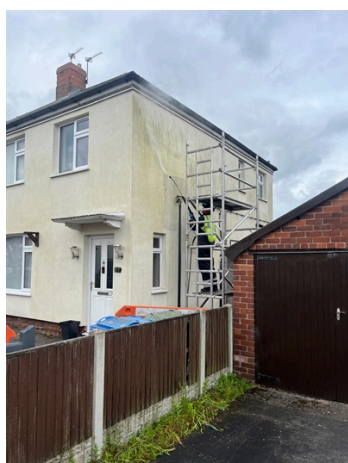
Preparation: Washing down the rendered walls with HP water & fungicidal wash prior to fixing any cracks or damaged rendered surfaces

All target surfaces were cleaned using HP water jetting at around 1,500psi
A fungicidal wash was incorporated to help destroy the existing mold and mildew
Any defects to the render were repaired and repointed using traditional methods in line with Belzona 5122 Instructions for use
Belzona 5122 was mixed at a 9:1 ratio with clean water. 9 parts clean water to 1 part Belzona 5122
This was applied to the walls using a low pressure back-pack spray until all target surfaces were coated

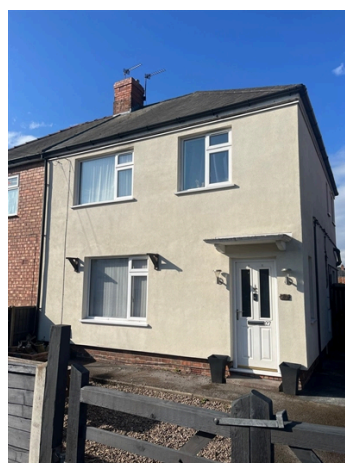
The property prepared ready for the application of Belzona 5122

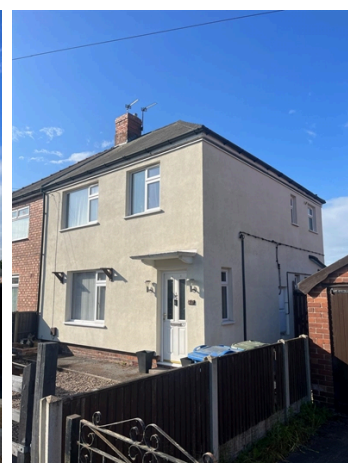
The property after the application of the Belzona 5122, appearing completely invisible

There has been no sign of the return of mold or mildew and, since the trial went ahead, a further 13 properties have been listed for the same application, leading to 180 assets eventually being treated over the next 18 months
