Containment Pond

ID: 9533

Industry: *General Industry*
Application: *TCC-Tanks and Chemical Containment Areas*
Substrate: *Concrete*
Products: *Belzona 3121 (MR7), Belzona 5231 (SG Laminate)*

Customer Location: *Dayton TN*
Application Date: *June 2023*

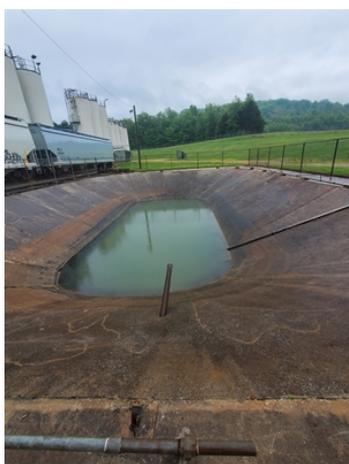
The containment area was very old and was suffering issues with cracking. The containment area was not in use but looked really bad for the inspectors of the plant. They wanted to save the area in case they decided to use it.

Containment area before restoration.

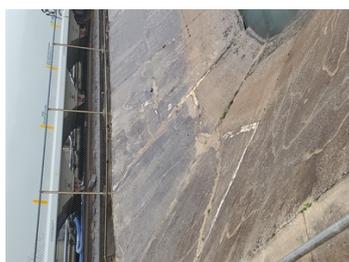
Cracks on the side of the containment area

The contractor pressure washed the area and used a pump to remove the water. The cracks were repaired with Belzona 3121 and reinforcing cloth 9331. Then two coats of Belzona 5231 were applied.

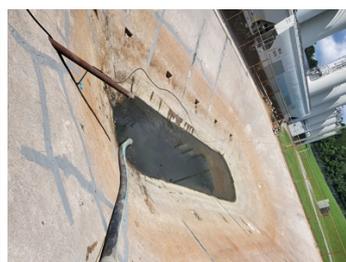
Cracks being repaired with Belzona 3121

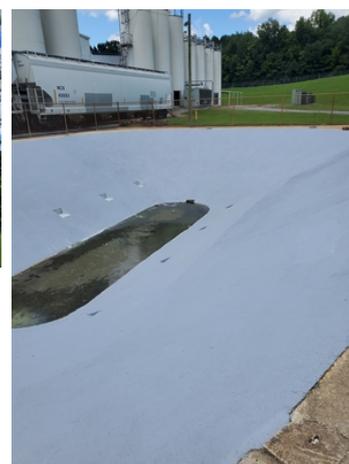
Containment area finished with two coats of Belzona 5231
