# Containment Pond

ID: 9533

Industry: General Industry  
Application: TCC-Tanks and Chemical Containment Areas  
Substrate: Concrete  
Products: Belzona 3121 (MR7), Belzona 5231 (SG Laminate)

Customer Location: Dayton TN  
Application Date: June 2023

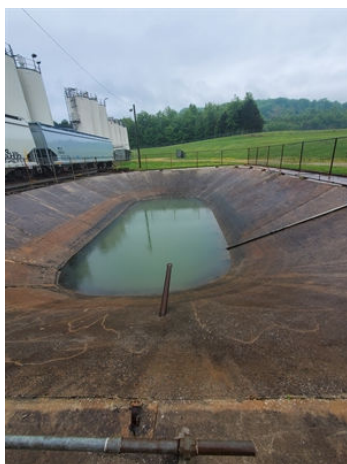
The containment area was very old and was suffering issues with cracking. The containment area was not in use but looked really bad for the inspectors of the plant. They wanted to save the area in case they decided to use it.

Containment area before restoration.

The contractor pressure washed the area and used a pump to remove the water. The cracks were repaired with Belzona 3121 and reinforcing cloth 9331. Then two coats of Belzona 5231 were applied.

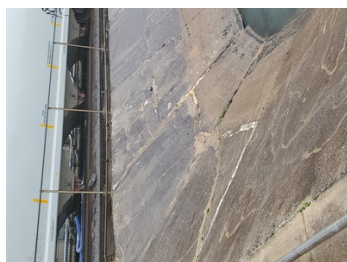
Cracks on the side of the containment area

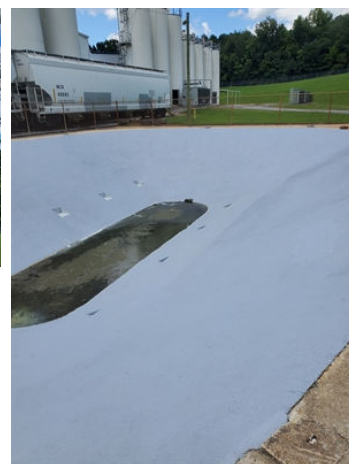
Containment area finished with two coats of Belzona 5231
