# Sand Filter Repair

**Industry:** Steel & Metal Processing

**Application:** TCC-Tanks and Chemical Containment Areas

**Substrate:** Carbon steel

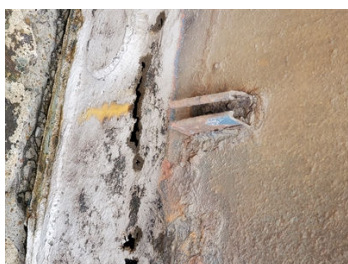
The filter tank was leaking in several areas. The base of the tank had very thin walls. It was in such bad shape it was unsafe to do the repairs from the inside.

Damage on the tank.

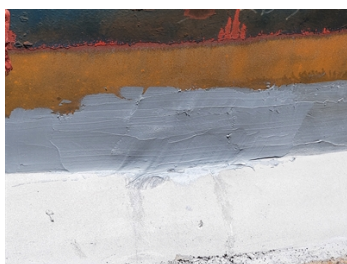
Application of Belzona 4111.

The area around the bottom of the tank was cleaned and Belzona 4111 was applied around the base of the tank. The metal was prepped any wet area we used Belzona 9611 to stop the leaks and Belzona 1161 and reinforcing cloth was used to fill in any voids and holes. then 1982 Superwrap was used around the bottom part of the tank to cover the 1161.

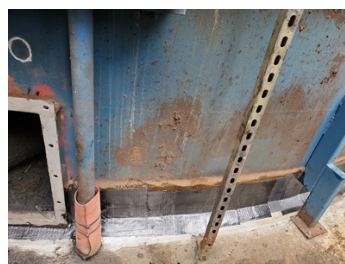
The base of the tank surface is prepped.

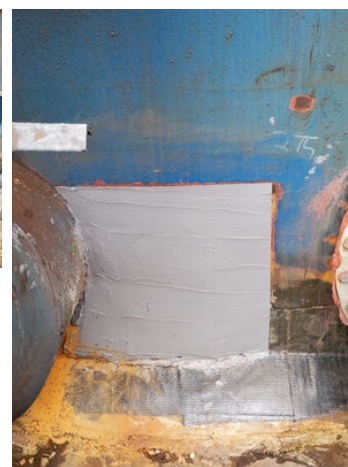
Finished application.
