Belzona Repairs and Reinforces Crack and Weakened Sewage Pipe in Polymer Plant

ID: 9542

Application: VPF-Valves, Pipes and Fittings

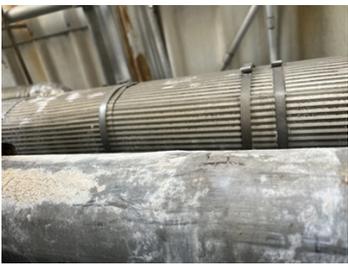
Stainless Steel pipe carrying sewage water with polymer particles was cracked and leaking. Customer was convinced after extensive scrutiny and technical support.

Pipe before surface preparation.

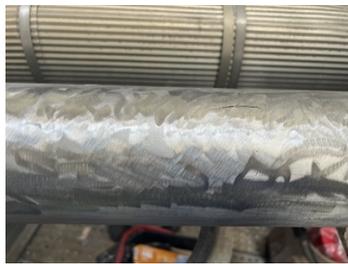
Pipe after surface preparation

Surface preparation was carried out using Acetone to clean the surface of the pipe before power tool cleaning. The surface was again cleaned with Acetone and allowed to dry. Then, Belzona 1212 was applied and allowed to stabilize. Afterwards, the Belzona Superwrap II system was installed and consolidated.

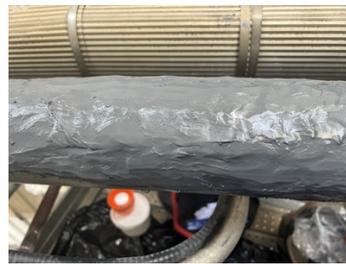
After application of Belzona 1212.

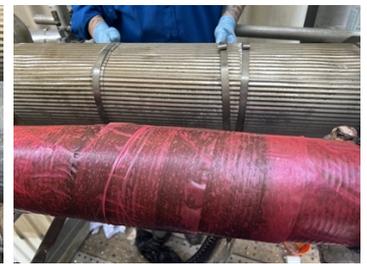
After application of SuperWrap II system.
