Belzona Repairs and Reinforces Crack and Weakened Sewage Pipe in Polymer Plant

ID: 9542

Application: VPF-Valves, Pipes and Fittings

Application Date: September 2024

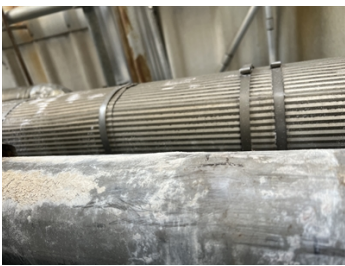
Stainless Steel pipe carrying sewage water with polymer particles was cracked and leaking. Customer was convinced after extensive scrutiny and technical support.

Pipe before surface preparation.

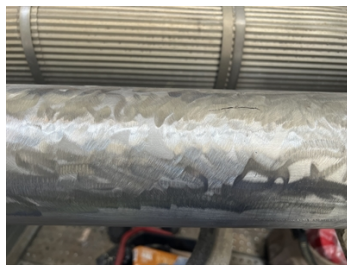
Pipe after surface preparation

Surface preparation was carried out using Acetone to clean the surface of the pipe before power tool cleaning. The surface was again cleaned with Acetone and allowed to dry. Then, Belzona 1212 was applied and allowed to stabilize. Afterwards, the Belzona Superwrap II system was installed and consolidated.

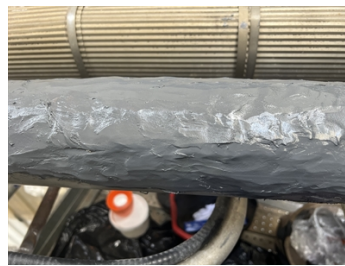
After application of Belzona 1212.

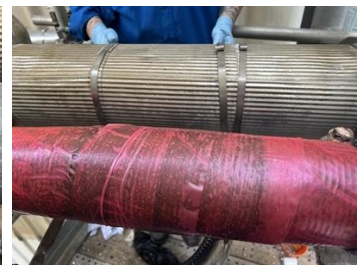
After application of SuperWrap II system.
