HYDRAULIC RAM REPAIR FOR HEAVY-DUTY MARINE LIFTER

ID: 9546

Industry: Marine
Application: MPT-Mechanical Power Transmission

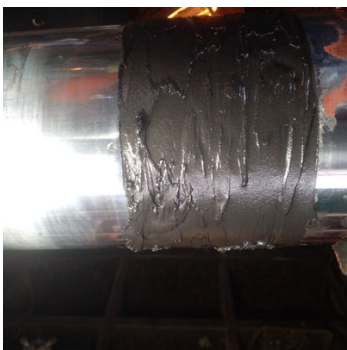
Belzona 1131 applied

Application: The prepared areas were then treated with Belzona 1131, a self-lubricating epoxy, which was applied precisely to rebuild the damaged seal area.

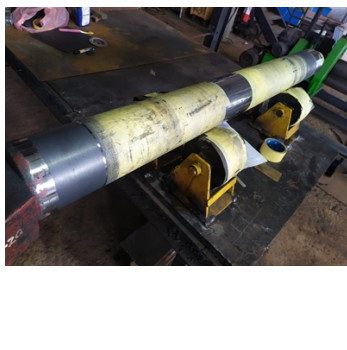
Machined (by using lathe machine)

Finishing: Once cured, the surface was polished to ensure smoothness and fit within the hydraulic system's tolerances, ensuring effective sealing and operation.

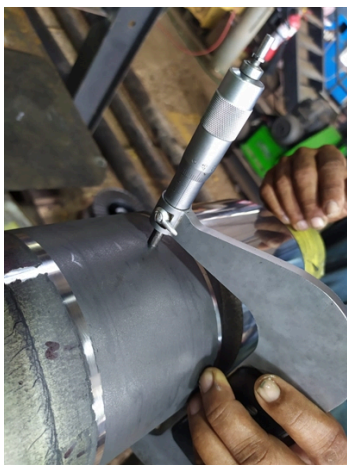
Smoothness, Tolerances checking (QA)

The repaired Pistons rods were pressure tested on the Dockyard Testing Rig at a pressure of 200 Bar.
