# HYDRAULIC RAM REPAIR FOR HEAVY-DUTY MARINE LIFTER

ID: 9546

Customer Location: Colombo, Sri Lanka.  
Application Date: September 2024

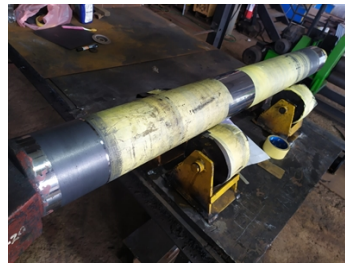
Machined (by using lathe machine)

**Finishing:** Once cured, the surface was polished to ensure smoothness and fit within the hydraulic system's tolerances, ensuring effective sealing and operation.

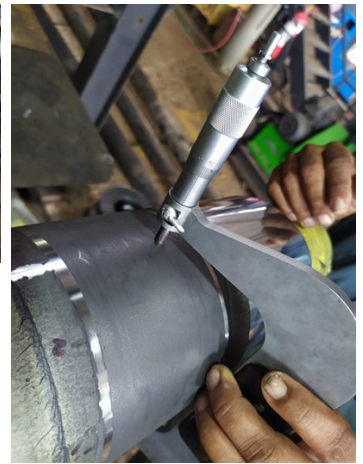
Smoothness, Tolerances checking (QA)

The repaired Pistons rods were pressure tested on the Dockyard Testing Rig at a pressure of 200 Bar.
