Corrosion in water storage tanks

ID: 9559

Industry: Water / Wastewater
Application: TCC-Tanks and Chemical Containment Areas
Substrate: Carbon steel
Products: Belzona 1121 (Super XL-Metal)

Customer Location: Riverview New Brunswick
Application Date: September 2024

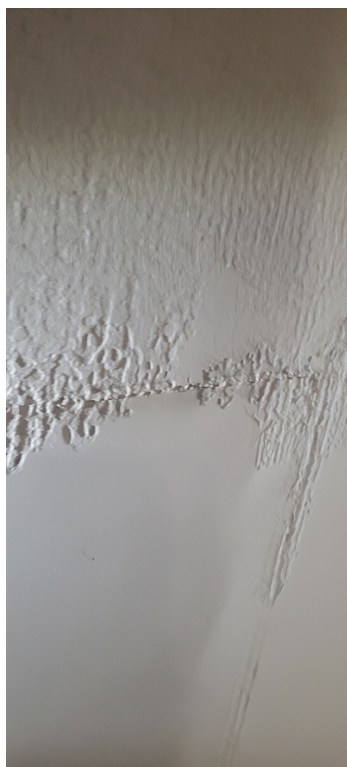
Pitting caused by corrosion.

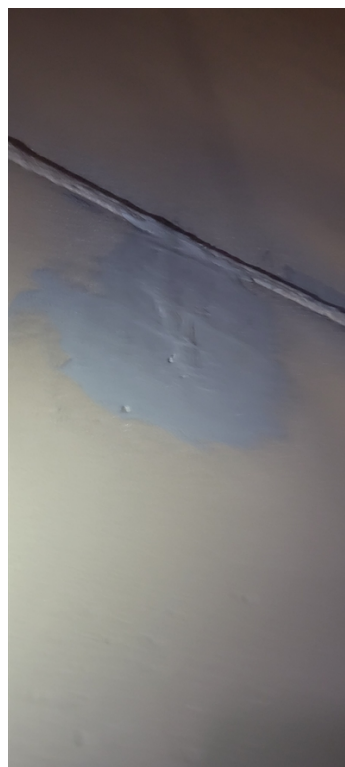
Pitting caused by corrosion at the inside of the water storage tank.

Belzona 1121 applied to fill in the pits.
