Caustic Tank repaired with Belzona

ID: 9560

Industry: Pulp & Paper

Customer Location: Port Alberni, BC

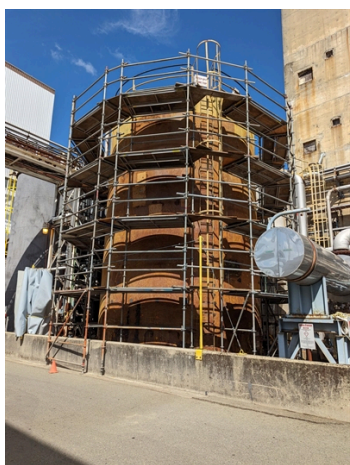
This tank was experiencing corrosion issue due to failed CUI. Areas had failed and water and contaminants came into contact with the steel tank and severe corrosion was occurring. 6 through holes were found

Tank experiencing corrosion.

All problems areas were located and sandblasted.

All leaks were stemmed using Belzona 9611 / 1221. Plates were bonded in place using Belzona 1111 Super Metal and then coated using Belzona 5811 immersion Grade.

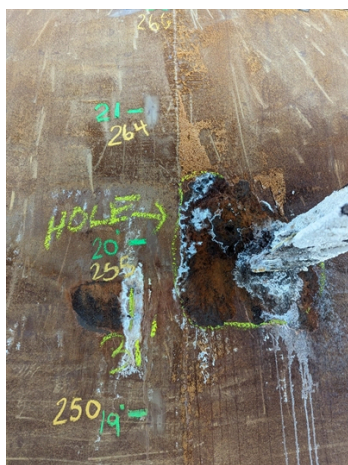
Close-up of corrosion.

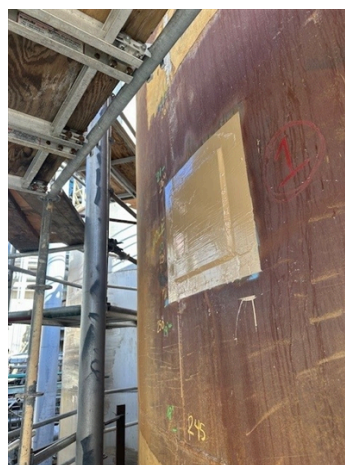
Close-up of finished application of plate bonding.
