# Caustic Tank repaired with Belzona

Industry: Pulp & Paper

Customer Location: Port Alberni, BC

Application: TCC-Tanks and Chemical Containment Areas

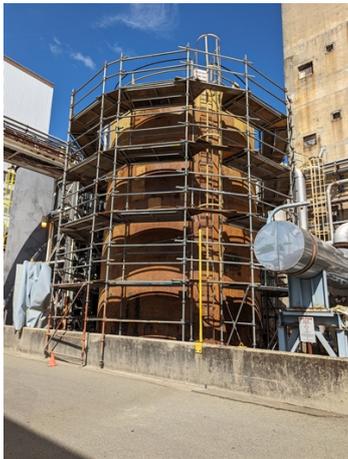
This tank was experiencing corrosion issue due to failed CUI. Areas had failed and water and contaminants came into contact with the steel tank and severe corrosion was occurring. 6 through holes were found

Tank experiencing corrosion.

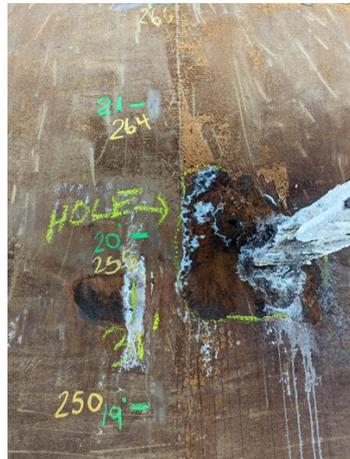
Close-up of corrosion.

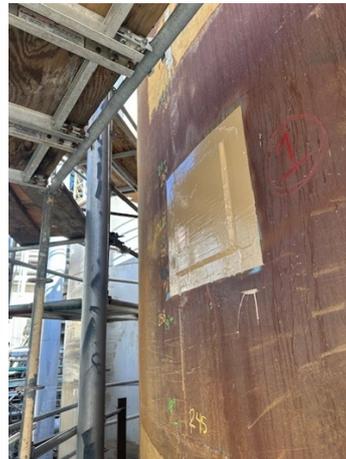
Close-up of finished application of plate bonding.

All leaks were stemmed using Belzona 9611 / 1221. Plates were bonded in place using Belzona 1111 Super Metal and then coated using Belzona 5811 immersion Grade.

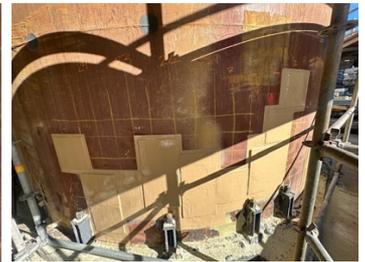
Finished application of plate bonding.
