Belzona repairs tile lining

ID: 9562

Industry: *Pulp & Paper*

Application: *SHM-Solids Handling Machinery*

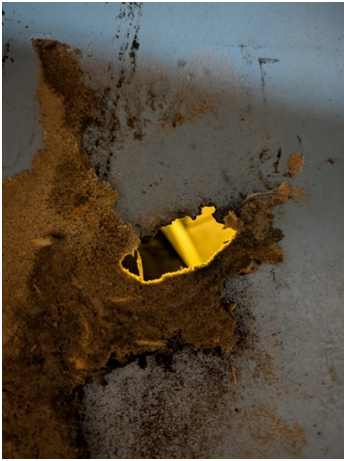
Holes in multiple locations due to missing tiles

One of many holes

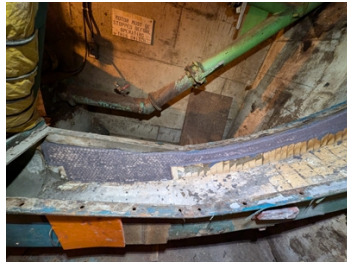
Holes repaired and tiles installed with grout

Surface mechanically prepared with hand tools, tiles bonded and grouted with Belzona

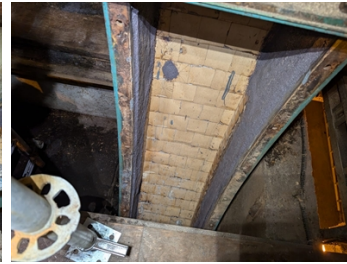
Completed application
