# Belzona Relines Cooling Tower Pan

**Industry:** Heating, Ventilation & Air Conditioning  
**Application:** TCC-Tanks and Chemical Containment Areas  
**Substrate:** Carbon steel  
**Products:** Belzona 5815

**Customer Location:** Nova Scotia  
**Application Date:** May 2024

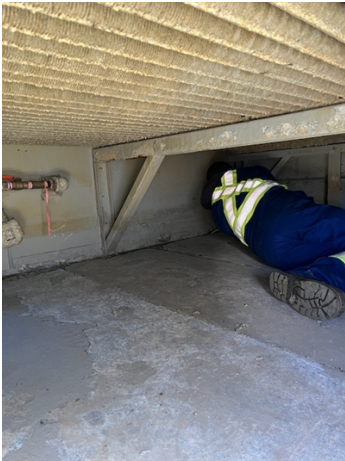
The existing coating liner was failing and required replacement.

Previous coating system.

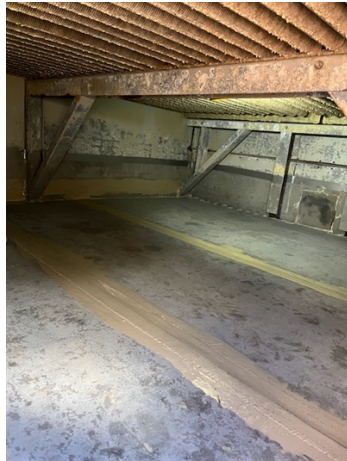
Belzona 9371 fibreglass strips wetted out with Belzona 5815 to bridge joints.

Belzona 5815 was used to wet out strips of Belzona 9371 fibreglass reinforcement to seal seams and joints. Belzona 5815 was then used as a two coat system first by applying beige as the first coat, the grey as the top coat. The Belzona 5815 coating was then cured at ambient temperatures for approximately 10 days before the cooling tower was refilled.

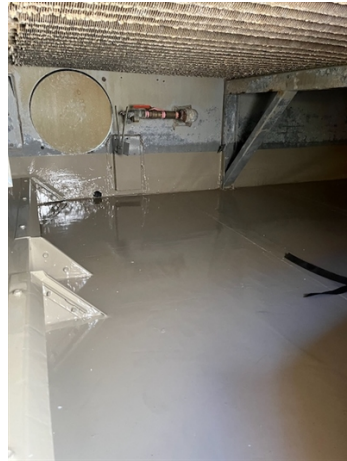
First coat of Belzona 5815 beige.

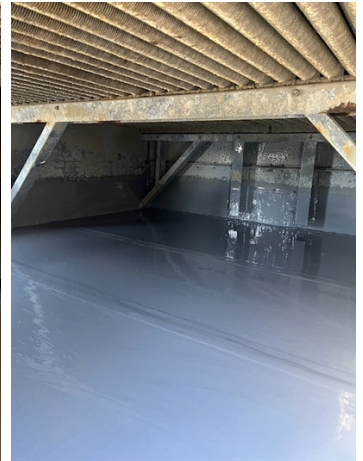
Second coat of Belzona 5815 grey.
