Belzona Relines Cooling Tower Pan

ID: 9563

Industry: Heating, Ventilation & Air Conditioning
Application: TCC-Tanks and Chemical Containment Areas
Substrate: Carbon steel
Products: Belzona 5815

Customer Location: Nova Scotia
Application Date: May 2024

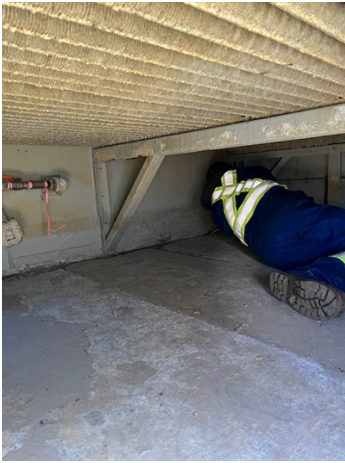
The existing coating liner was failing and required replacement.

Previous coating system.

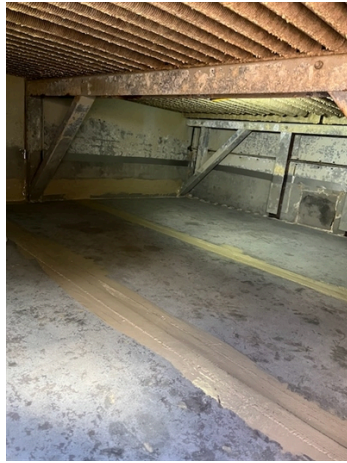
Belzona 9371 fibreglass strips wetted out with Belzona 5815 to bridge joints.

Belzona 5815 was used to wet out strips of Belzona 9371 fibreglass reinforcement to seal seams and joints. Belzona 5815 was then used as a two coat system first by applying beige as the first coat, the grey as the top coat. The Belzona 5815 coating was then cured at ambient temperatures for approximately 10 days before the cooling tower was refilled.

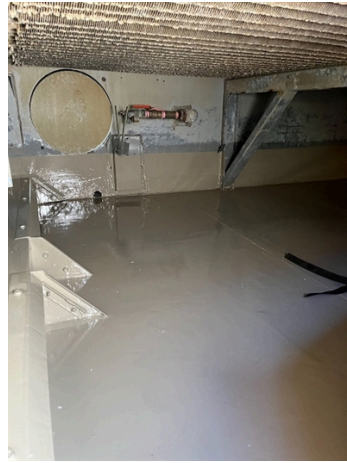
First coat of Belzona 5815 beige.

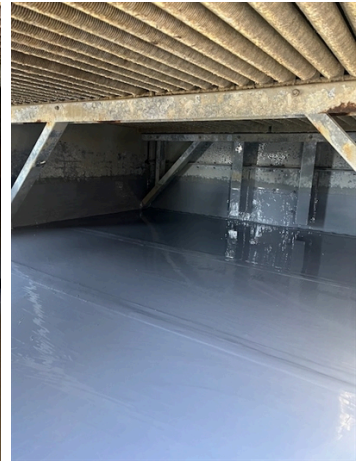
Second coat of Belzona 5815 grey.
