# Rebuild and Coating of Heat Exchangers

ID: 9566

Industry: Power

Application: HEX-Heat Exchangers

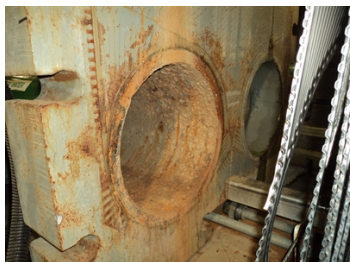
Customer was having a problem with leaking heat exchanger plates due to corrosion.

Picture shows the root cause of the issue .

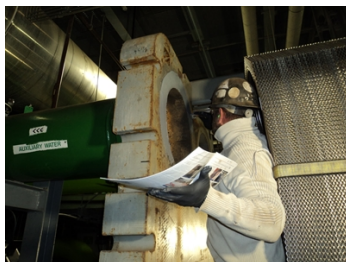
Pictures showing the application of Belzona 1111.

Power tooling was chosen for preparation was used due to no blasting inside the plant, and coating was applied with brush and rollers

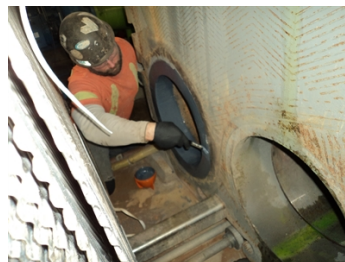
Picture showing the application of the Belzona 1321.

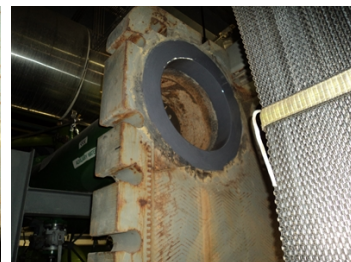
Picture showing completed application both coats of Belzona 1321.
