Plate patch on chip chute

ID: 9567

Industry: *Pulp & Paper*
Application: *TCC-Tanks and Chemical Containment Areas*
Substrate: *Carbon steel*
Products: *Belzona 1212*

Customer Location: *Castlegar*
Application Date: *September 2024*

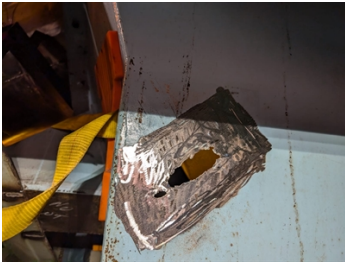
Hole found in chip chute, causing a mess of material on the floor.

Hole prepared for repair.

Area cleaned and degreased. Surfaces hand tool prepared, cloth and metal patch used with Belzona 1212 for long term protection.

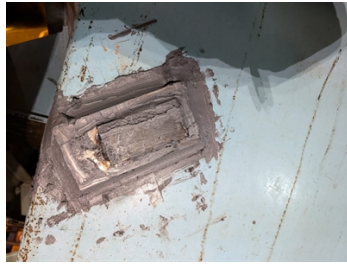
Belzona 1212 used to bond plate.
