Belzona Provides Grip and Wear Resistance to Log Ladder

ID: 9575

Industry: *Other*
 Application: *SHM-Solids Handling Machinery*

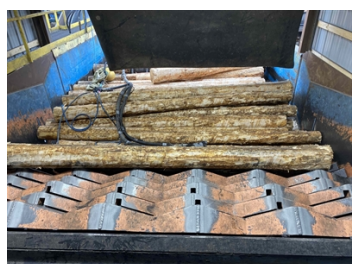
Steel grit blasted at welds that would frequently wear away.

The steel was grit blasted and Belzona 1818 was mixed and applied, with thick coverage, to protect from wear.

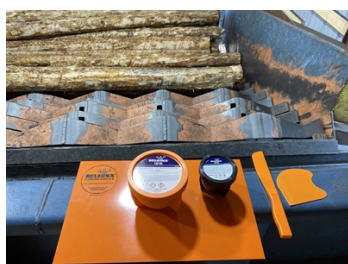
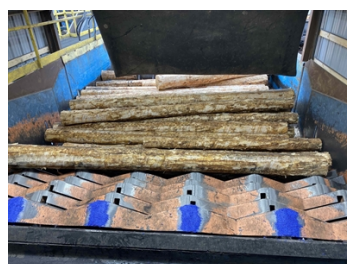
Belzona 1818 ready to be used. Belzona 1818 applied.

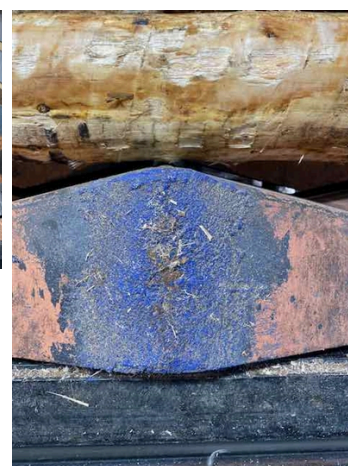
Application 7 months later.

The Belzona 1818 was found to still be protecting and in excellent condition 7 months after the application.
