Belzona Provides Grip and Wear Resistance to Log Ladder

ID: 9575

Industry: *Other*
 Application: *SHM-Solids Handling Machinery*

Substrate: *Carbon steel*
 Products: *Belzona 1818*

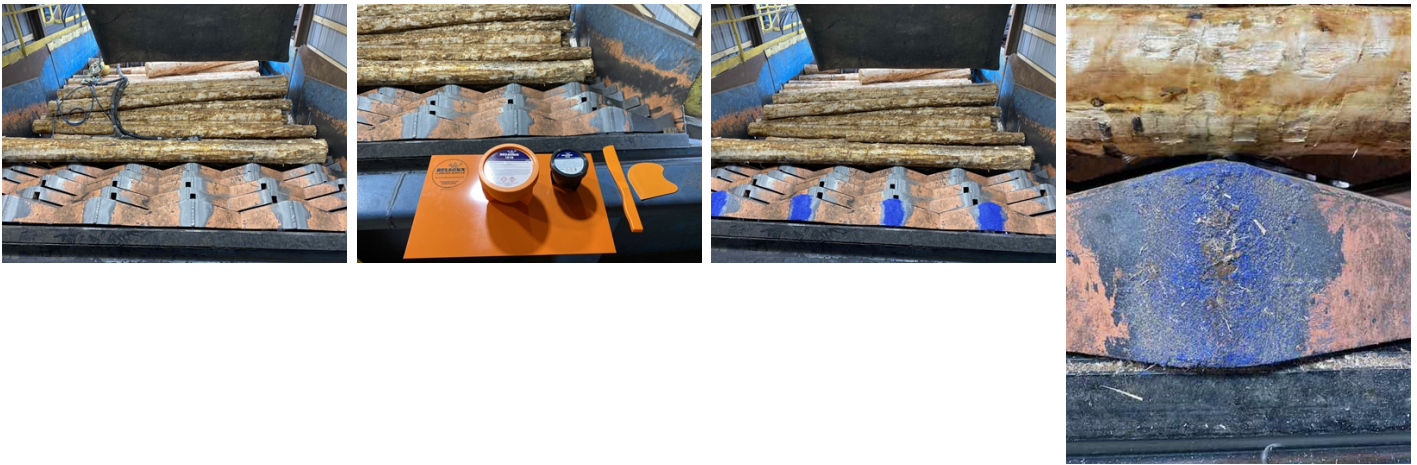
The welds on the log ladder were wearing away, and any protective coating was too smooth causing interference to the laser system monitoring the equipment.

Steel grit blasted at welds that would frequently wear away.

Belzona 1818 ready to be used.

Belzona 1818 applied.

Application 7 months later.

The use of Belzona 1818 allowed for fast curing and provided wear resistance protecting the welds of the log ladder. The colour and roughness of Belzona 1818 also allowed the laser system to monitor the feed of logs to work properly.

The steel was grit blasted and Belzona 1818 was mixed and applied, with thick coverage, to protect from wear.

The Belzona 1818 was found to still be protecting and in excellent condition 7 months after the application.
