Belzona protects coal chute

ID: 9579

Industry: *Mining & Quarrying*
Application: *SHM-Solids Handling Machinery*

Substrate: *Carbon steel*
Products: *Belzona 1331*

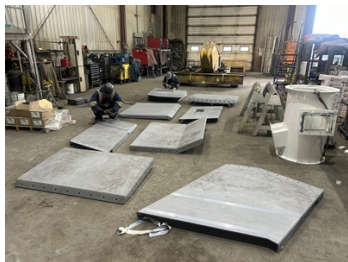
Pieces of chute grit blades in shop

Grit blast was completed, degreased all surfaces and Belzona was applied according to IFU document.

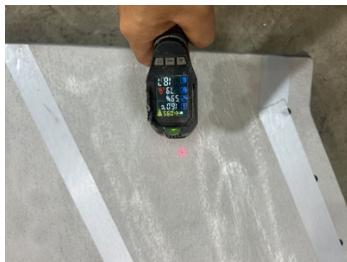
Environmental taken for QC documentation.

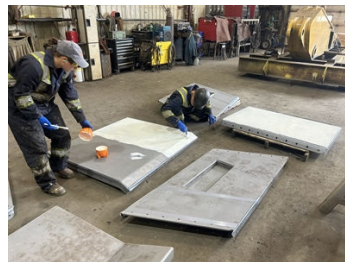
Application in progress

During a shutdown it was decided to trial Belzona on a chute liner to prevent coal sticking and downtime. Easy mixing and application made quick work of the lining areas.

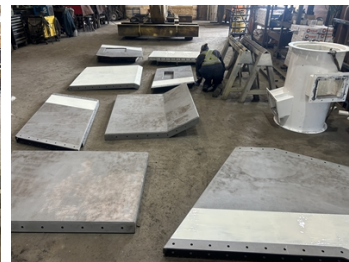
Completed application

This application has worked very well that the client is looking to have many other areas coated to prevent downtime and production stoppages.
