Drain grate for swimming pool frame gets Belzona 4111 repair

ID: 9580

Industry: Water / Wastewater
Application: FPA-Floor Problem Areas
Substrate: Masonry
Products: Belzona 4111 (Magma-Quartz)

Customer Location: Vancouver, BC
Application Date: March 2024

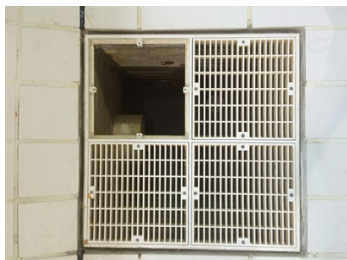
The grate perimeter seal was cracked, allowing water to migrate through and get under the tiles.

The previous product was non-existent in the cavity. Area shows that the previous product used was no longer present in the cavity.

An angle grinder was used to prep the surface then Belzona conditioner and 4111 magma quartz were installed to seal and stabilize the grate.

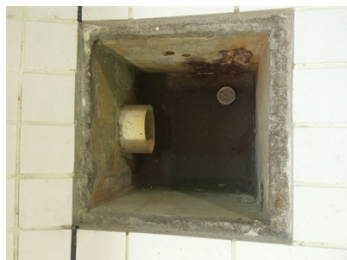
Drain cover set in place for application.

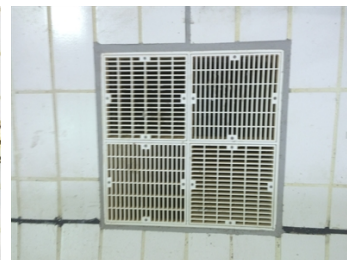
Filled and finished off using Belzona 4111.
