Rebuild surface and structural strength of diffuser pump component

ID: 9582

Industry: Power
Application: CEP-Centrifugal Pumps
Substrate: Cast Iron
Products: Belzona 1121 (Super XL-Metal), Belzona SuperWrap, Belzona 4111 (Magma-Quartz), Belzona 4141 (Magma-Build)

Customer Location: Etobicoke
Application Date: September 2024

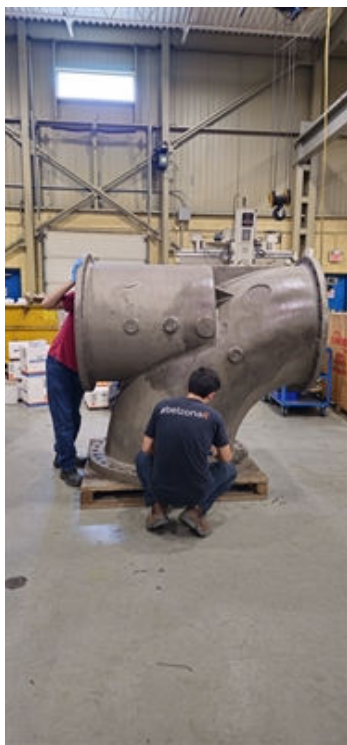
The customer experienced significant erosion issues within the diffuser pump component and, after conducting tests, determined that the structural strength of the part needed to be reinforced.

Diffuser Component

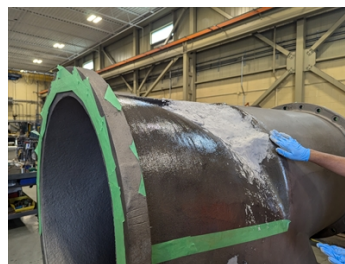
Belzona 1341 for coating inside the surface

Belzona 1341 – To address erosion-corrosion issues on the internal surfaces of the pump.

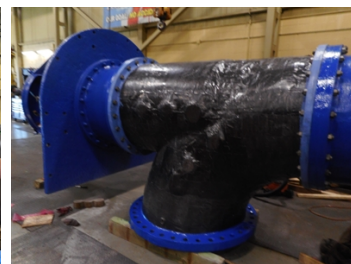
Belzona 4141 application to make a uniform shape.

Completed work with Belzona Superwrap II

Belzona 4141 – To get component in uniform shape for superwrap application.

Belzona SuperWrap II (Belzona 9381, 1981, 1982) – To strengthen the structural integrity of the component.
