Creating Irregular Shim for Tracked Skidder Axle

ID: 9589

Industry: Other
Application: GSS-Gaskets, Seals and Shims
Substrate: Carbon steel
Products: Belzona 1111 (Super Metal)

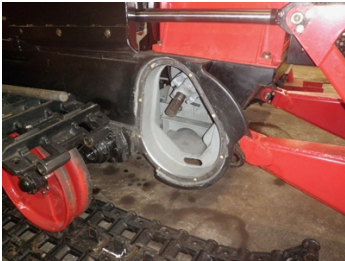
The final drive housing seat is not damaged, but it is out of alignment due to frame distortion. The mating surface will be cleaned and prepped with a mechanical blaster and all bolt holes corked, then Belzona 1111 will be applied over it.

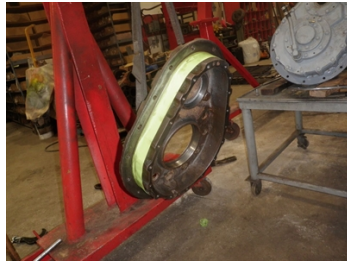
A final drive housing with the mating flange coated with release agent is used as a former to create a new, properly aligned seat.

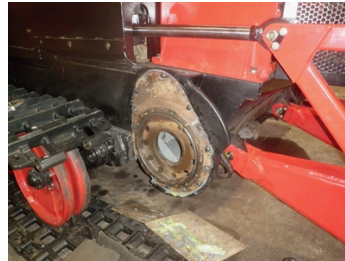
The drive housing is installed immediately after the Belzona 1111 is applied, and aligned while the product is still soft. Excess material is exuded, and it is allowed to cure.

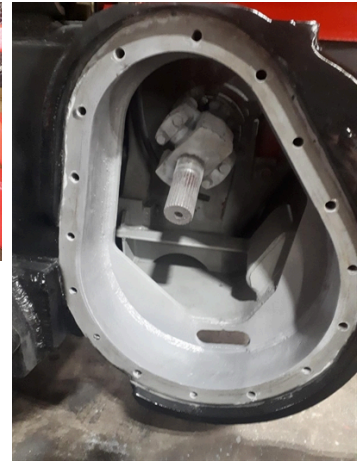
When the drive housing is removed, the new, properly aligned seat is revealed.
