Creating Irregular Shim for Tracked Skidder Axle

ID: 9589

Industry: *Other*
Application: *GSS-Gaskets, Seals and Shims*
Substrate: *Carbon steel*
Products: *Belzona 1111 (Super Metal)*

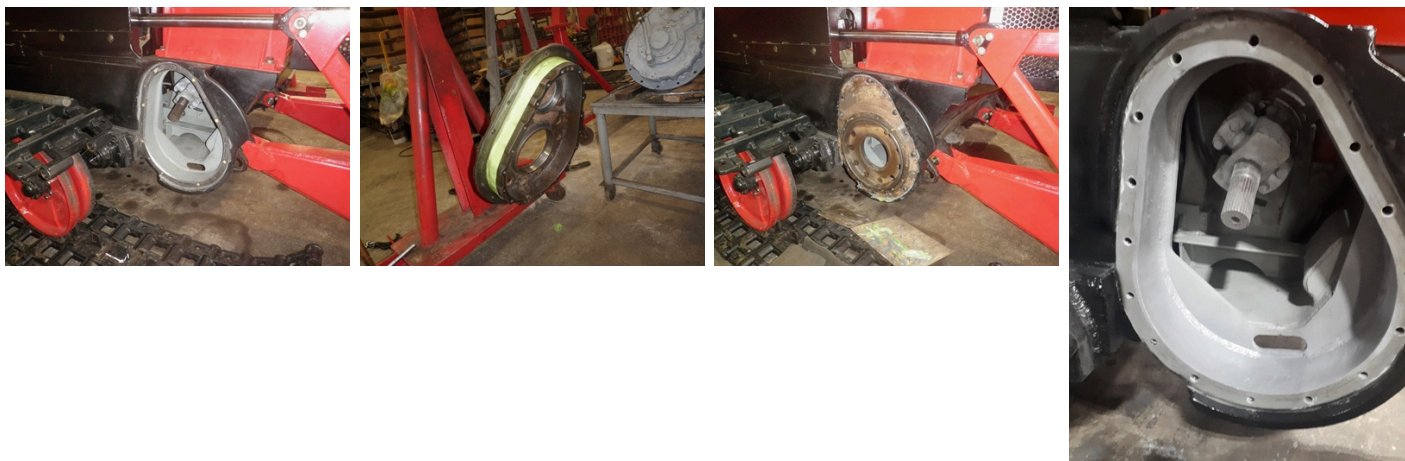
A tracked skidder used in forestry had sustained damage which distorted the frame, causing one track drive to be slightly out of alignment even after the frame had been straightened,

The final drive housing seat is not damaged, but it is out of alignment due to frame distortion. The mating surface will be cleaned and prepped with a mechanical blaster and all bolt holes corked, then Belzona 1111 will be applied over it.

A final drive housing with the mating flange coated with release agent is used as a former to create a new, properly aligned seat.

The drive housing is installed immediately after the Belzona 1111 is applied, and aligned while the product is still soft. Excess material is exuded, and it is allowed to cure.

When the drive housing is removed, the new, properly aligned seat is revealed.

Belzona offered a relatively fast and considerably less expensive option of properly aligning the final drive housing; the alternative was to strip the frame completely and attempt to re-straighten the frame, which would have taken several days and may or may not have been successful.

No special tools were used, aside from a Bristle Blaster for surface preparation.
