# Repair Marine Seawater Cooling Pump

ID: 9591

Industry: Marine  
Application: CEP-Centrifugal Pumps  
Substrate: Cast Iron  
Products: Belzona 1111 (Super Metal), Belzona 1212

Customer Location: Victoria, BC, Canada  
Application Date: May 2024

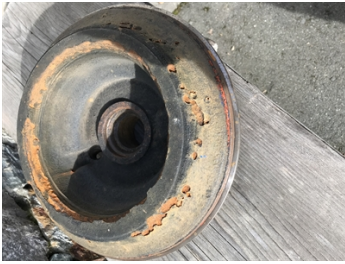
This pump casing was extremely corroded and eroded creating an unacceptable efficiency.

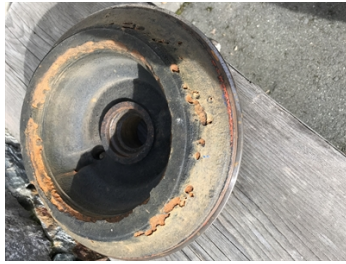
The pump casing shows more corrosion and erosion
