Belzona repairs expansion joint leak

ID: 9592

Industry:	Steel & Metal Processing	Customer Location:	Trail
Application:	VPF-Valves, Pipes and Fittings	Application Date:	May 2024
Substrate:	Stainless-steel		
Products:	Belzona 2311 (SR Elastomer),Belzona 2911 (Elastomer QD Conditioner)

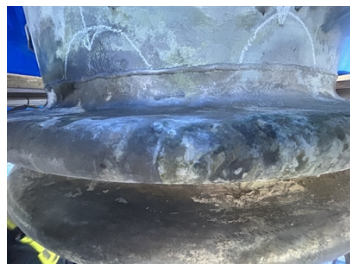
Holes in an acid tank expansion joint needed to be repaired without welding.

Holes found

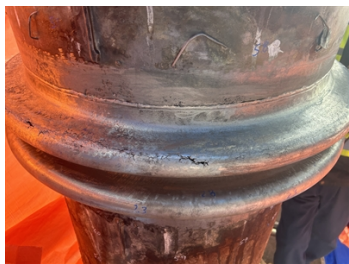
Preparation completed

Area cleaned and neutralized, conditioner applied followed by elastomer with reinforcement cloth.

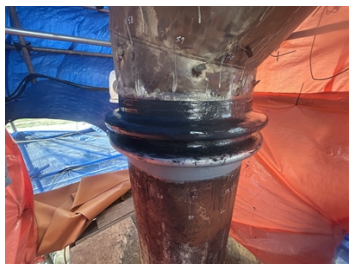
Belzona elastomer and cloth applied
