Repair of the damaged wall and bottom of the boiler condensation container

ID: 9600

Industry: Heating, Ventilation & Air Conditioning
Application: TCC-Tanks and Chemical Containment Areas
Substrate: Carbon steel
Products: Belzona 1511 (Super HT-Metal), Belzona 1593

Customer Location: Slovakia
Application Date: August 2021

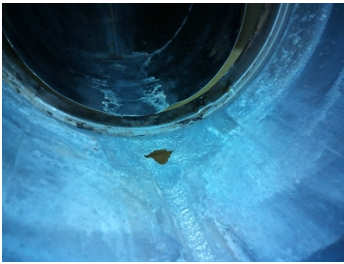
When using the Buderus condensing boiler, the bottom and walls of the boiler were damaged by corrosion.

Damaged bottom and walls of the boiler.

Corrosion caused damage to the bottom and walls of the boiler, making further use impossible.

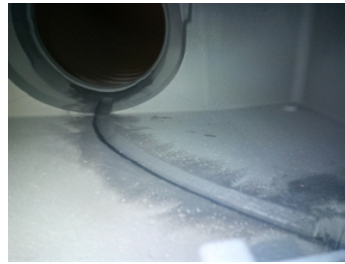
The missing original material was supplemented with the Belzona 1511 product.
