Repair of the damaged wall and bottom of the boiler condensation container

ID: 9600

Industry: Heating, Ventilation & Air Conditioning
Application: TCC-Tanks and Chemical Containment Areas
Substrate: Carbon steel
Products: Belzona 1511 (Super HT-Metal), Belzona 1593

Customer Location: Slovakia
Application Date: August 2021

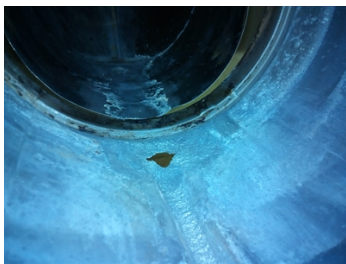
When using the Buderus condensing boiler, the bottom and walls of the boiler were damaged by corrosion.

Damaged bottom and walls of the boiler.

Corrosion caused damage to the bottom and walls of the boiler, making further use impossible.

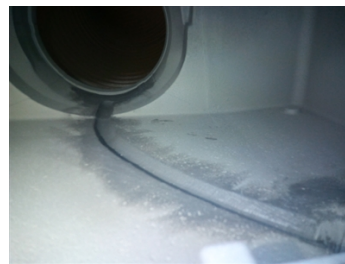
The missing original material was supplemented with the Belzona 1511 product.

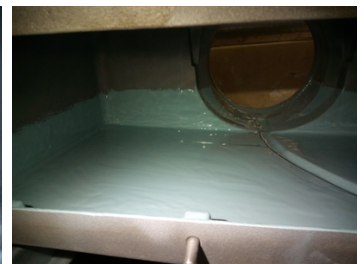
Both the bottom and the walls were treated with the product Belzona 1593.
