Anti-corrosive protection of the gutter on the water treatment plant.

ID: 9601

Industry: *Water / Wastewater*
Application: *TCC-Tanks and Chemical Containment Areas*
Substrate: *Carbon steel*
Products: *Belzona 5811 (Immersion Grade)*

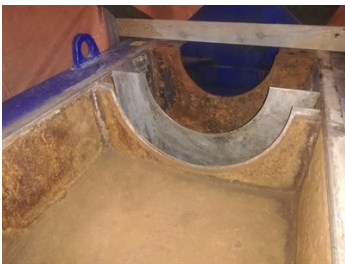
Corrosive damage to the gutter. Before applying Belzona products, it was necessary to blast the gutter.

Blasting the surface to the required standard Sa 2.5. Application of protective coating Belzona 5811 in two layers.

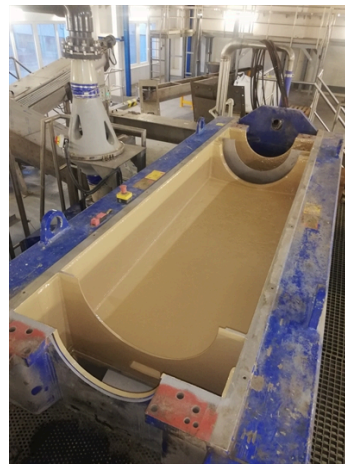
Application of the first layer of Belzona 5811.

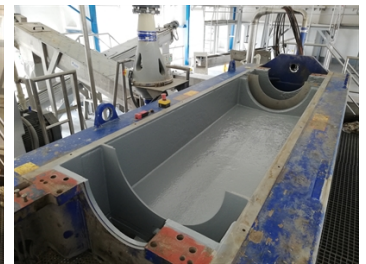
Application of the second layer of Belzona 5811.
