Belzona 1212 and Belzona 9621 stop the pulp water leak.

ID: 9604

Industry: *Pulp & Paper*
Application: *VPF-Valves, Pipes and Fittings*
Substrate: *Stainless-steel*
Products: *Belzona 1212, Belzona 9621*

Customer Location: *Oklahoma*
Application Date: *October 2024*

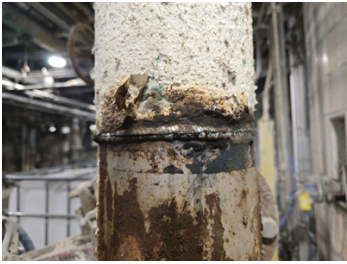
The stainless steel pipe seam had a defective weld allowing the pulp processing water to leak from the joint and had been for many years.

Original Condition.

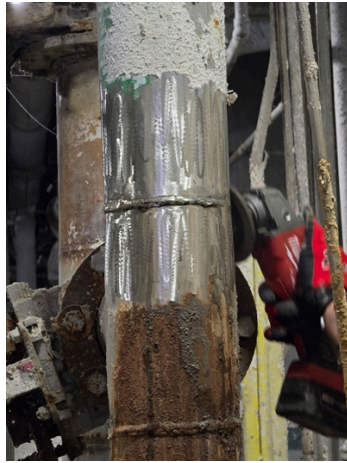
Removing the rust and pulp fiber and roughening the surface.

Battery powered grinder was used to both clean and prep the surface, and was washed down with solvent prior to the application.

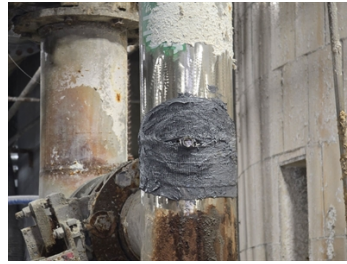
Belzona 1212, 9341, and 9621 in place.

This repair was able to be done because of the water tolerant capabilities of Belzona 1212. That allowed the repair to be completed while the water was leaking.
