Belzona 1212 and Belzona 9621 stop the pulp water leak.

ID: 9604

Industry: Pulp & Paper
Application: VPF-Valves, Pipes and Fittings
Substrate: Stainless-steel
Products: Belzona 1212, Belzona 9621

Customer Location: Oklahoma
Application Date: October 2024

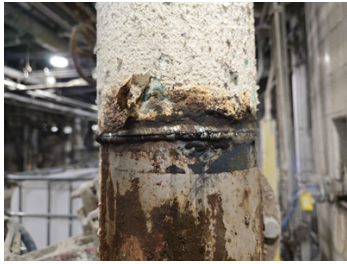
The stainless steel pipe seam had a defective weld allowing the pulp processing water to leak from the joint and had been for many years.

Original Condition.

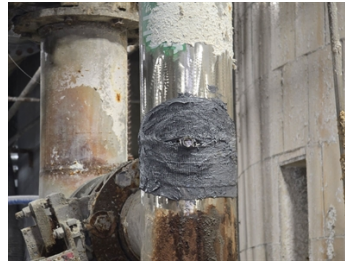
Belzona 1212, 9341, and 9621 in place.

This repair was able to be done because of the water tolerant capabilities of Belzona 1212. That allowed the repair to be completed while the water was leaking.

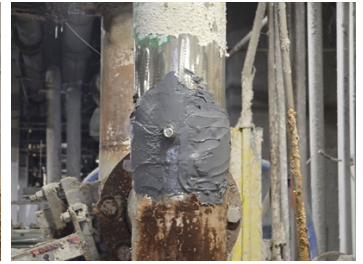
Final layer of Belzona 1212 applied.
