Belzona Restored and Protected the Oil Sealing Surface of Wind Turbine

Industry: *Power*
 Application: *FBC-Fans, Blowers and Compressors*

Customer Location: *Yunnan, China*
 Application Date: *August 2023*

Substrate: *Carbon steel*
 Products: *Belzona 1311 (Ceramic R-Metal)*

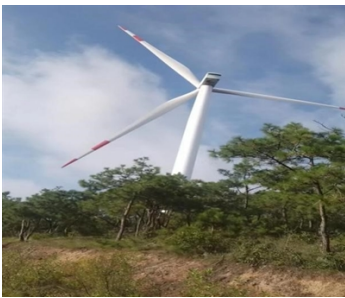
Full view of wind turbine

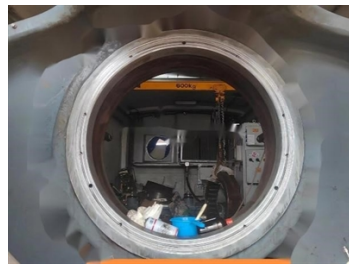
The oil sealing surface of a wind turbine at the wind farm were worn out and needed to be repaired.

Sealing face before repair

The operating temperature was ambient. Wind farms were very windy and the sealing surface of the wind turbine was heavily abraded.

The application was carried out in accordance with Belzona Know-How leaflets FBC-05. Surface preparation was carried out by grinding with an angle grinder, followed by repair and protection of the sealing surfaces with Belzona 1311.

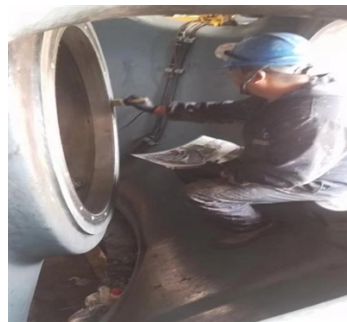
During application

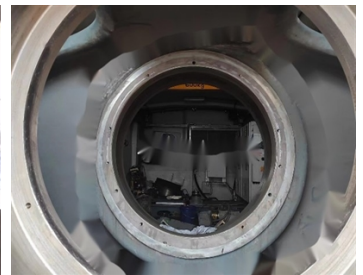
Application finished

After four months of use, no leaks were seen in the inspection and the client was very satisfied with the results. This solution greatly reduced the cost of replacement for the client, as well as downtime.
