# Belzona Restored and Protected the Oil Sealing Surface of Wind Turbine

ID: 9607

**Industry:** Power**Application:** FBC-Fans, Blowers and Compressors**Customer Location:** Yunnan, China**Application Date:** August 2023**Substrate:** Carbon steel**Products:** Belzona 1311 (Ceramic R-Metal)**Problem**

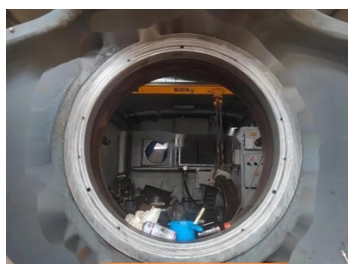
The oil sealing surface of a wind turbine at the wind farm were worn out and needed to be repaired.

Sealing face before repair

The operating temperature was ambient. Wind farms were very windy and the sealing surface of the wind turbine was heavily abraded.

The application was carried out in accordance with Belzona Know-How leaflets FBC-05. Surface preparation was carried out by grinding with an angle grinder, followed by repair and protection of the sealing surfaces with Belzona 1311.

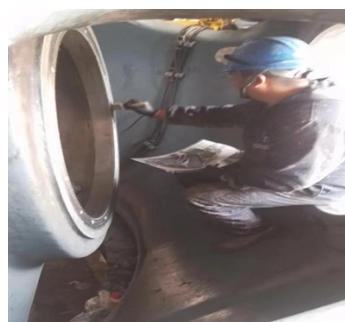
During application

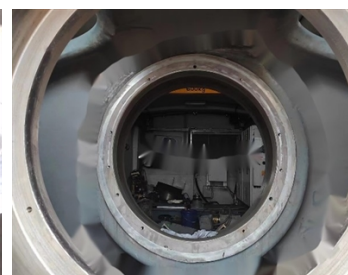
Application finished

After four months of use, no leaks were seen in the inspection and the client was very satisfied with the results. This solution greatly reduced the cost of replacement for the client, as well as downtime.
