# Protection of the bottom of the tank against corrosion

ID: 9608

Industry: *Chemical & Petrochemical*  
Application: *TCC-Tanks and Chemical Containment Areas*  
Substrate: *Carbon steel*  
Products: *Belzona 1391T*

Customer Location: *Slovakia*  
Application Date: *May 2022*

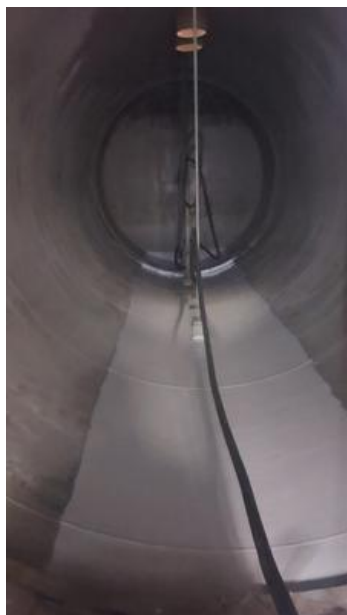
*Damage appeared on the bottom of the tank due to corrosion.*

Detail of blasting.

Surface blasting to Sa 2.5 with a profile of 75 µm. Surface degreasing. Application of the product Belzona 1391 T in two layers with a total thickness of approx. 900 µm. Curing of material

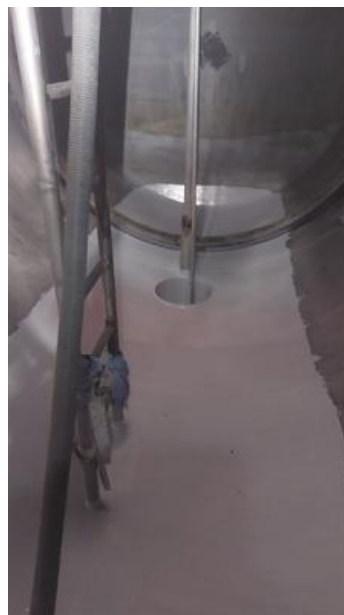
Blasted tank bottom.
