Belzona 4341 rescues the Fibroc pump

ID: 9614

Industry: *Fluid Flow* Customer Location: *Washington*
 Application: *CEP-Centrifugal Pumps* Application Date: *October 2017*
 Substrate: *Composite*
 Products: *Belzona 4341 (Magma CR4), Belzona 4911 (Magma TX Conditioner)*

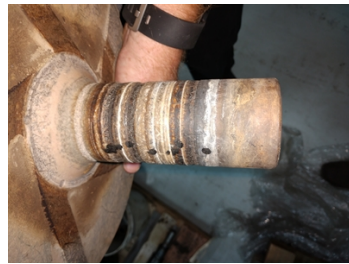
Shaft showing heavy uneven wear.

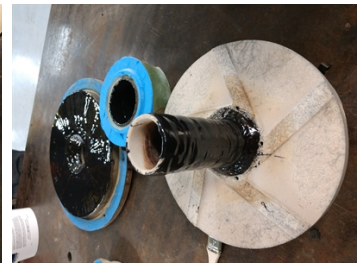
Showing some of the pieces with the application complete.

The cost of the Belzona materials for this pump was less than 10% of replacing it and reworking an entire production area to accommodate a new pump. With the heat, abrasion, and chemical resistance of the Belzona 4341, this was the perfect solution. This pump was still in operation 18 months later.
