Belzona cold plate bonds in flour silo

ID: 9617

Application: *TCC-Tanks and Chemical Containment Areas*

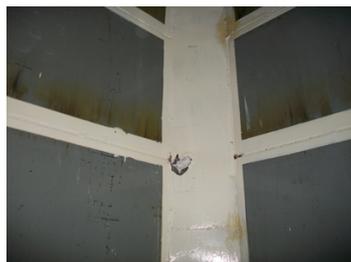
Corrosion in flour silos had lead to through wall defects

Corroded area

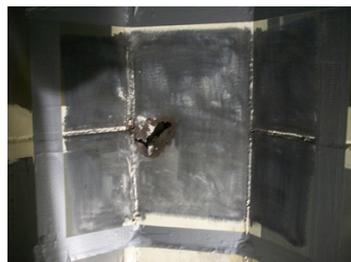
Preparation with MBX

A pneumatic MBX Bristle Blaster was used to prepare the metal surface. Plates were then bonded with Belzona 1111 to reinforce the holed areas. Two coats of Belzona 1341 were then applied to provide a low friction surface to prevent hand up of flour.

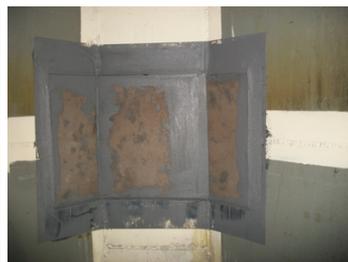
Plates bonded

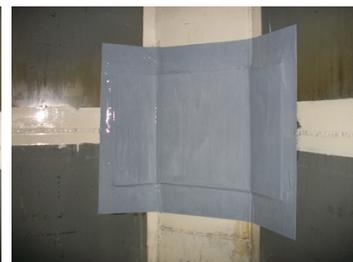
Overcoated with Belzona 1341
