# Belzona cold plate bonds in flour silo

ID: 9617

Application: *TCC-Tanks and Chemical Containment Areas*

Substrate: *Carbon steel*

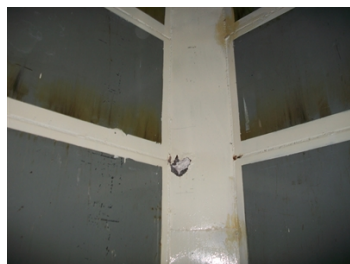
*Corrosion in flour silos had lead to through wall defects*

Corroded area

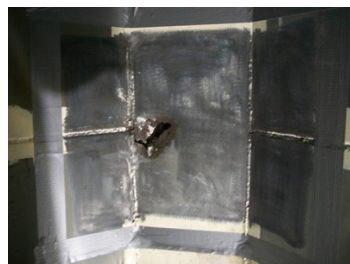
Preparation with MBX

A pneumatic MBX Bristle Blaster was used to prepare the metal surface. Plates were then bonded with Belzona 1111 to reinforce the holed areas. Two coats of Belzona 1341 were then applied to provide a low friction surface to prevent hand up of flour.

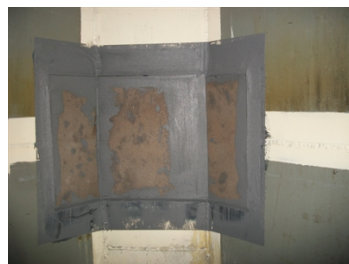
Plates bonded
