# Repair of the pinion shaft

Industry: *Cement*  
Application: *MPT-Mechanical Power Transmission*

Substrate: *Carbon steel*  
Products: *Belzona 1111 (Super Metal)*

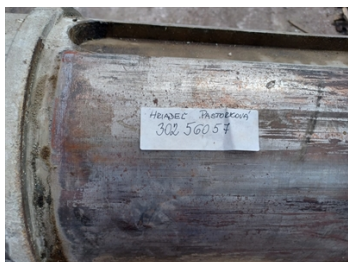
Damaged shaft under the bearing.

Due to long-term use of the machine, the shaft was damaged. The customer was looking for a quick and high-quality solution. Our company has very good results with such repairs.

Surface blasting according to the required Sa2.5 standard. Degreasing. Application of Belzona 1111 material. Curing. Processing to the required size.

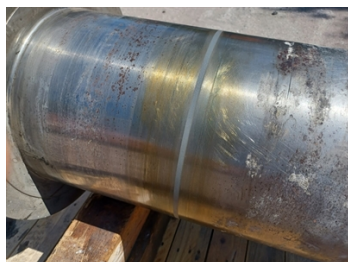
Repair detail

Shaft after repair

Belzona 1111 was used for the repair
