BELZONA REBUILDS SEA WATER FILTER FLANGES

ID: 962

Industry: Oil & Gas
Application: VPF-Valves, Pipes and Fittings
Substrate: 316 stainless steel
Products: Belzona® 1111 (Super Metal)

Customer Location: Gas Production Company, England
Application Date: September 2002

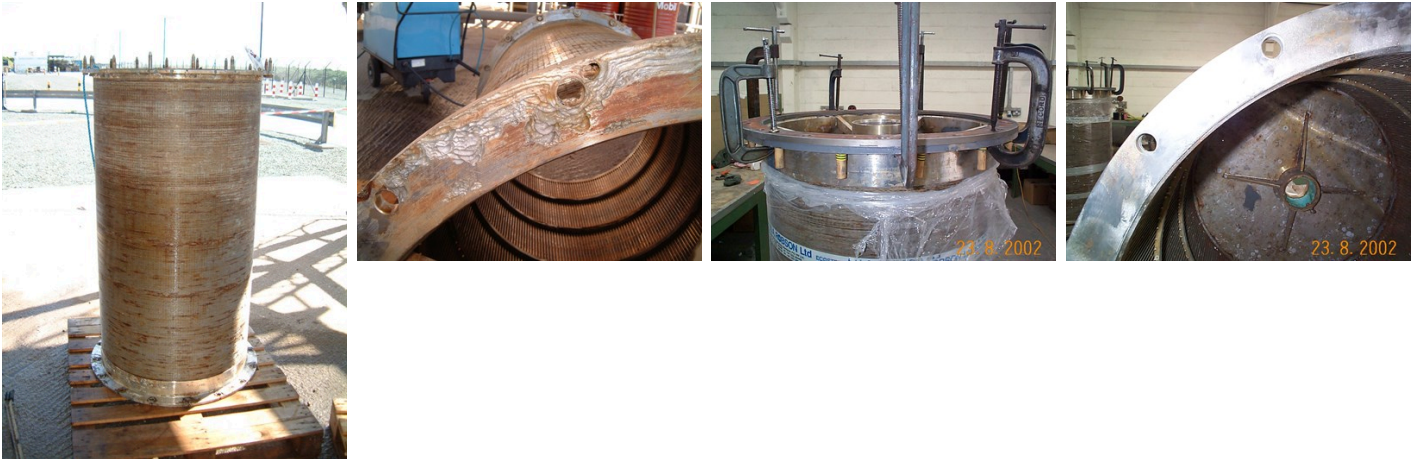
Photograph Descriptions

Severe crevice corrosion and galvanic cavities on the flanges.

* A section of a seawater filter basket , * Severe crevice corrosion on 18 flanges , * Belzona® 1111 in place and curing , * Final result ,

A former was manufactured and with the use of spacers,clamps and release agent, the Belzona® 1111 was formed into perfect flange faces.

Inspected in 2007 flanges still performing OK allowing equipment to be re-assembled with no remedial work required.
