BELZONA REBUILDS SEA WATER FILTER FLANGES

ID: 962

Industry: Oil & Gas
Application: VPF-Valves, Pipes and Fittings
Substrate: 316 stainless steel
Products: Belzona® 1111 (Super Metal)

Customer Location: Gas Production Company, England
Application Date: September 2002

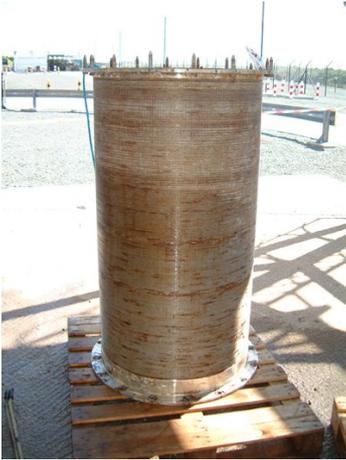
* A section of a seawater filter basket , * Severe crevice corrosion on 18 flanges , * Belzona® 1111 in place and curing , * Final result

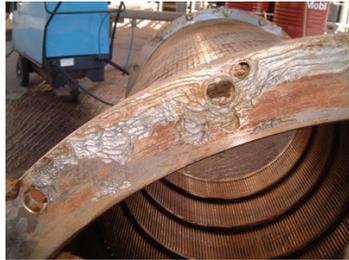
Severe crevice corrosion and galvanic cavities on the flanges.
