# Fan wheel protection against sticking

ID: 9620

Industry: *Cement*  
Application: *FBC-Fans, Blowers and Compressors*

Customer Location: *Slovakia*  
Application Date: *June 2024*

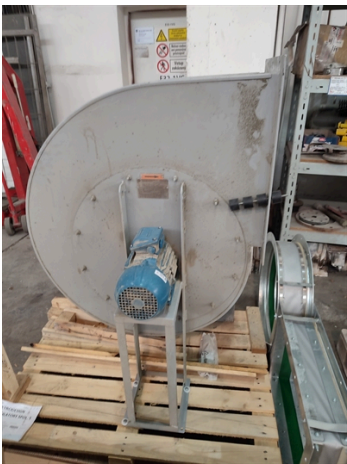
*The sticky material caused the wheel to run erratically.*

Fan wheel

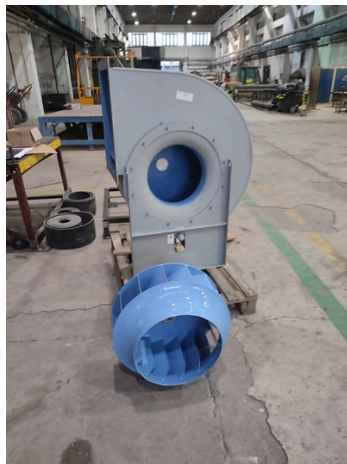
Application of the product  
Belzona 1341 on the wheel

Surface blasting according to the required Sa2.5 standard. Degreasing. Application of Belzona 1341 material on the cleaned surface of the device.

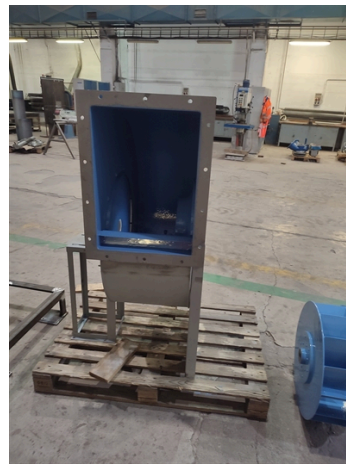
Application of the product  
Belzona 1341 on the fan box

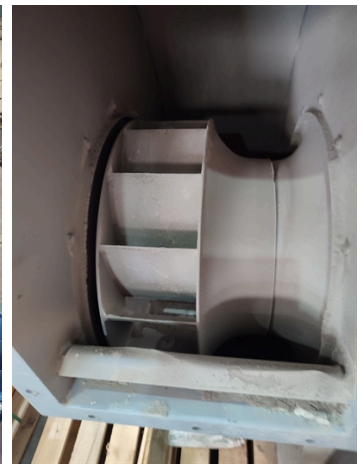
Fan wheel before repair
