Pump plinth rebuild

ID: 9622

Application: FPA-Floor Problem Areas

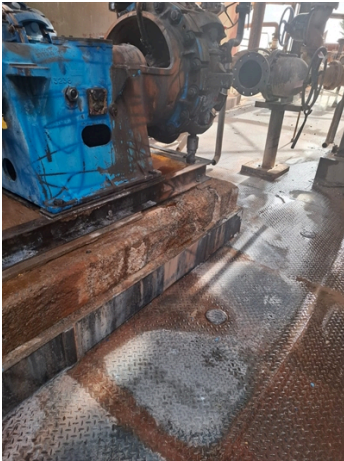
Over time the plinth surface had deteriorated due to constant contact with hot caustic.

Initial condition of plinth

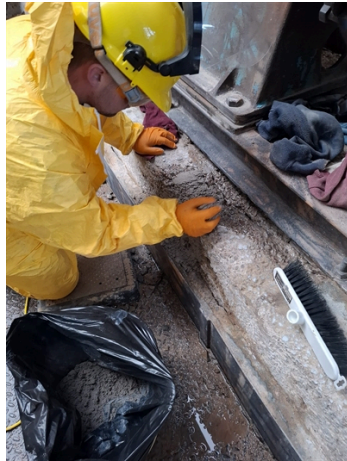
Application of Belzona 4131

4911 used as surface conditioner before application of 4131 which was used to rebuild profile of plinths.

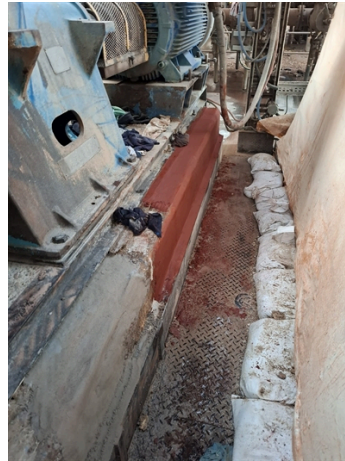
Application of Belzona 4181

4981 used as a conditioner before application of 4181 which will give resistance to caustic at elevated temperatures.

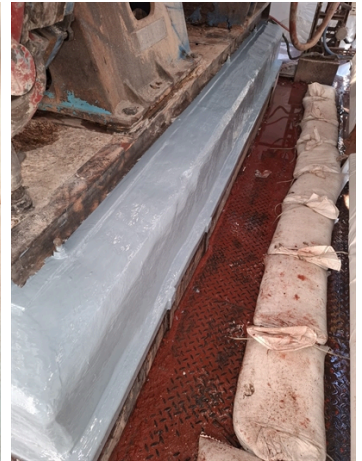
Overcoated with 1391T
