Roll Crusher abrasive lining

ID: 9625

Industry: *Water / Wastewater*
 Application: *SHM-Solids Handling Machinery*

Substrate: *Carbon steel*
 Products: *Belzona 1812 (Ceramic Carbide FP)*

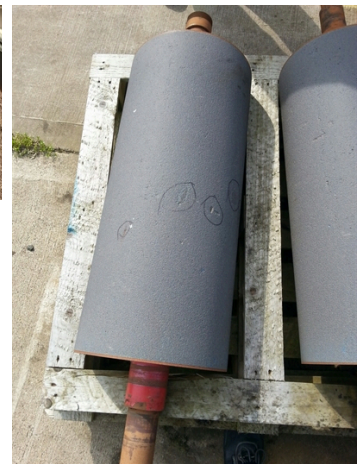
Roll crushers in use in a sludge processing plant were experiencing excessive wear in service.

Crusher before surface preparation

Surface prepared & wet out with Belzona 1812

5mm lining of Belzona 1812 applied

Roll crushers machined & put into service. Image taken 18 months, minor damage noted.

A profile was machined into the surface of the crushers. Scrubbing brushes were used to wet out the surface. 5mm of Belzona 1812 was then built up. The surface was then machined down flat on a large lathe with PCD cutting tools.

These crushers go into service for around 18 months before being taken out. Minor repairs from contact with hard objects is noted & can typically be spot repaired.
