Tank repair and protection

ID: 9626

Industry: Chemical & Petrochemical
Application: TCC-Tanks and Chemical Containment Areas
Substrate: Carbon steel
Products: Belzona 1111 (Super Metal), Belzona 5892

Customer Location: Slovakia
Application Date: March 2023

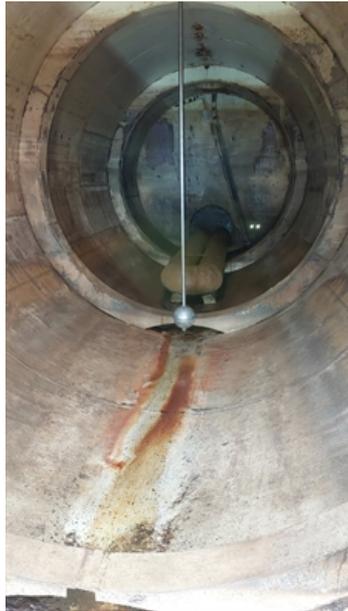
General view of the tank

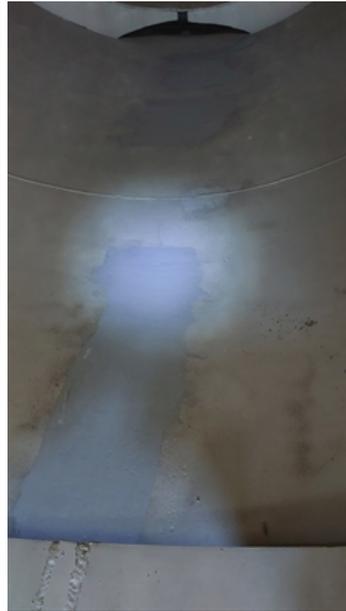
Corrosion damaged the bottom of the tank and there was a danger that the bottom of the tank would break through.

Damaged tank bottom

After a long time and due to aggressive chemicals from crude oil, the bottom of the tank was damaged. There was even a hole in the tank.

Surface blasting to Sa 2.5 with a profile of 75 µm up to the height of 1/3 of the shell.

Surface degreasing. Bonding of a metal plate to the bottom of the tank under the heating body (leakage at the bottom of the tank) with Belzona 1111.

Application of the product Belzona 5892 in a thickness of approx. 500 µm. Hardening of the material - by additional heating.
