# Repeated Coating of Split Casing Pump for Drinking Water

ID: 9629

Application: CEP-Centrifugal Pumps

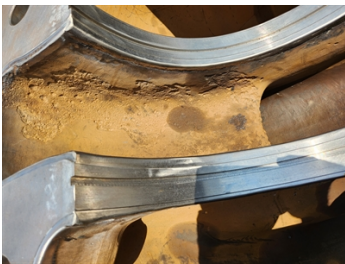
The pump owner was faced with the problem of erosion-corrosion inside the pump, causing pitted areas in the internal surface every two years. To solve this problem, Belzona's pump solution with rebuilding and coating was used.

Pitting damage on the pump casing

For the surface preparation, the pump was blasted to achieve a minimum profile of 75 microns and Near White Metal. Pitting and damages were rebuilt using Belzona 1111, and then 2-coat system of Belzona 1341N was applied in accordance with the Instruction For Use.

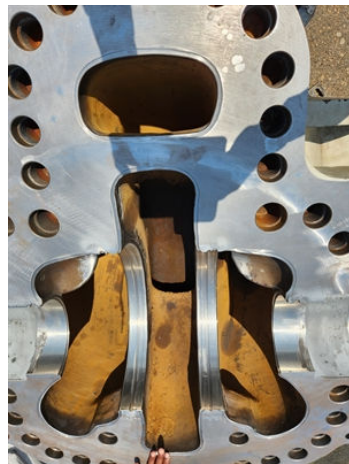
Pump casing before application

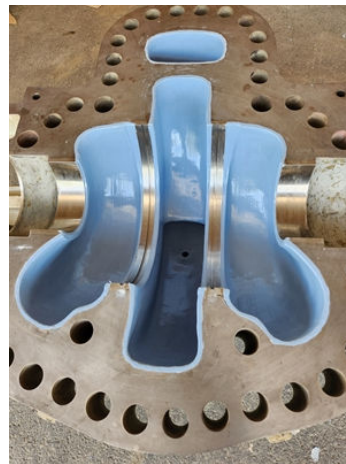
Pump casing protected with Belzona pump coating
