Belzona protect Spent Caustic Reactor

ID: 9631

Industry: Chemical & Petrochemical
Application: TCC-Tanks and Chemical Containment Areas
Substrate: Carbon steel
Products: Belzona 1511 (Super HT-Metal), Belzona 1593

Customer Location: Dammam, Saudi Arabia
Application Date: June 2024

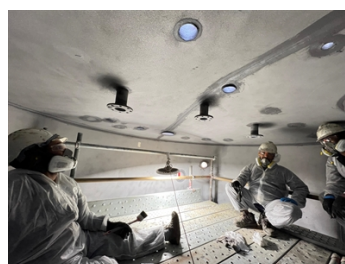
The customer relied on the reactor to treat spent caustic, but the old lining system had failed, causing frequent shutdowns that resulted in losses of \$20,000 per day. To address this issue, we recommended Belzona 1593 as a durable and effective solution.

Internal reactor body before coating

The old coating was removed, and the surface was prepared through blasting to achieve a minimum profile of 75 µm and a near-white metal finish. Belzona 1511 was applied to smooth out welding joints, while Belzona 1593 was used to coat and protect the entire reactor.
